**Report No. CG-D-08-00**

**EVALUATION OF WINDOW FAILURE MODES**

**FINAL REPORT  
DECEMBER 1999**

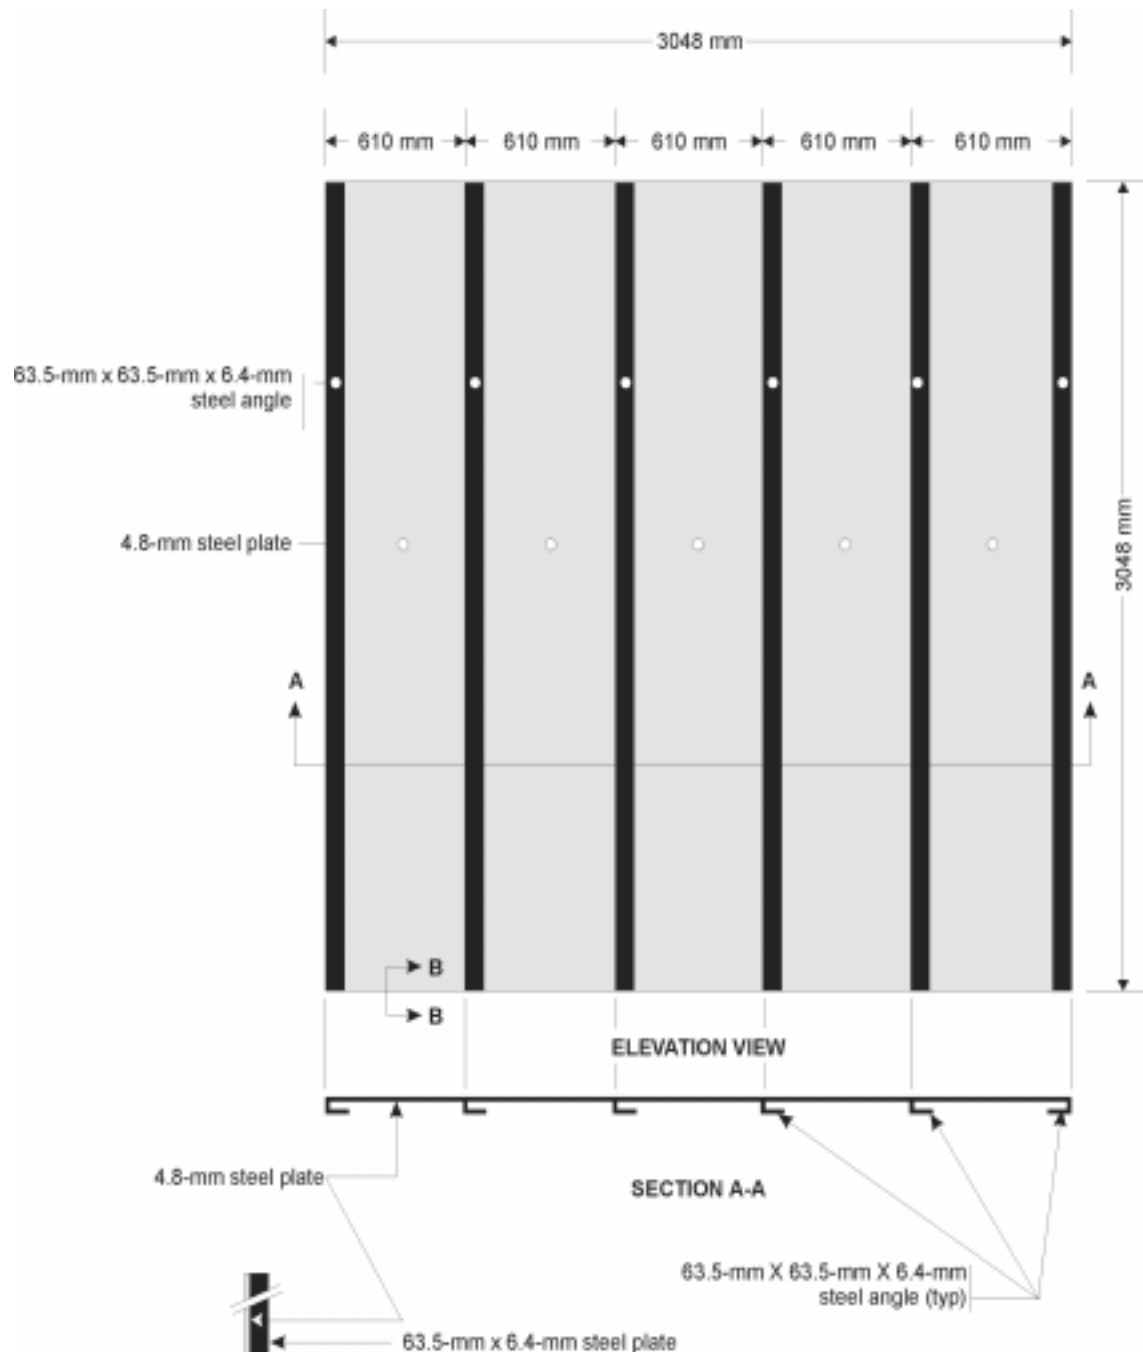
**Figure 1. Bulkhead construction.**

Two standard A-60 IMO bulkheads were constructed. Each test bulkhead was installed in a test frame such that all four edges of the bulkhead were restrained. Details of the test bulkheads are provided in Figure 1. Each bulkhead was constructed of nominal 4.5-mm (3/16-in) thick steel plate. The steel plate had the joints continuously welded from one side. The overall dimensions of the bulkheads were 2480 mm high and 3020 mm wide. The bulkheads had six 65 x 65 x 6 mm stiffeners. The stiffeners ran the height of the bulkheads, and the attachment (welding) of the stiffeners was as shown in Figure 1.

Note:  
 The steel bulkhead consisted of 4.8-mm steel plate, continuously welded on one side, reinforced with 63.5-mm x 63.5-mm x 6.4-mm steel angle stiffeners, positioned 610-mm o.c. as indicated. The top and bottom were reinforced with 63.5-mm x 6.4-mm steel plate as shown.

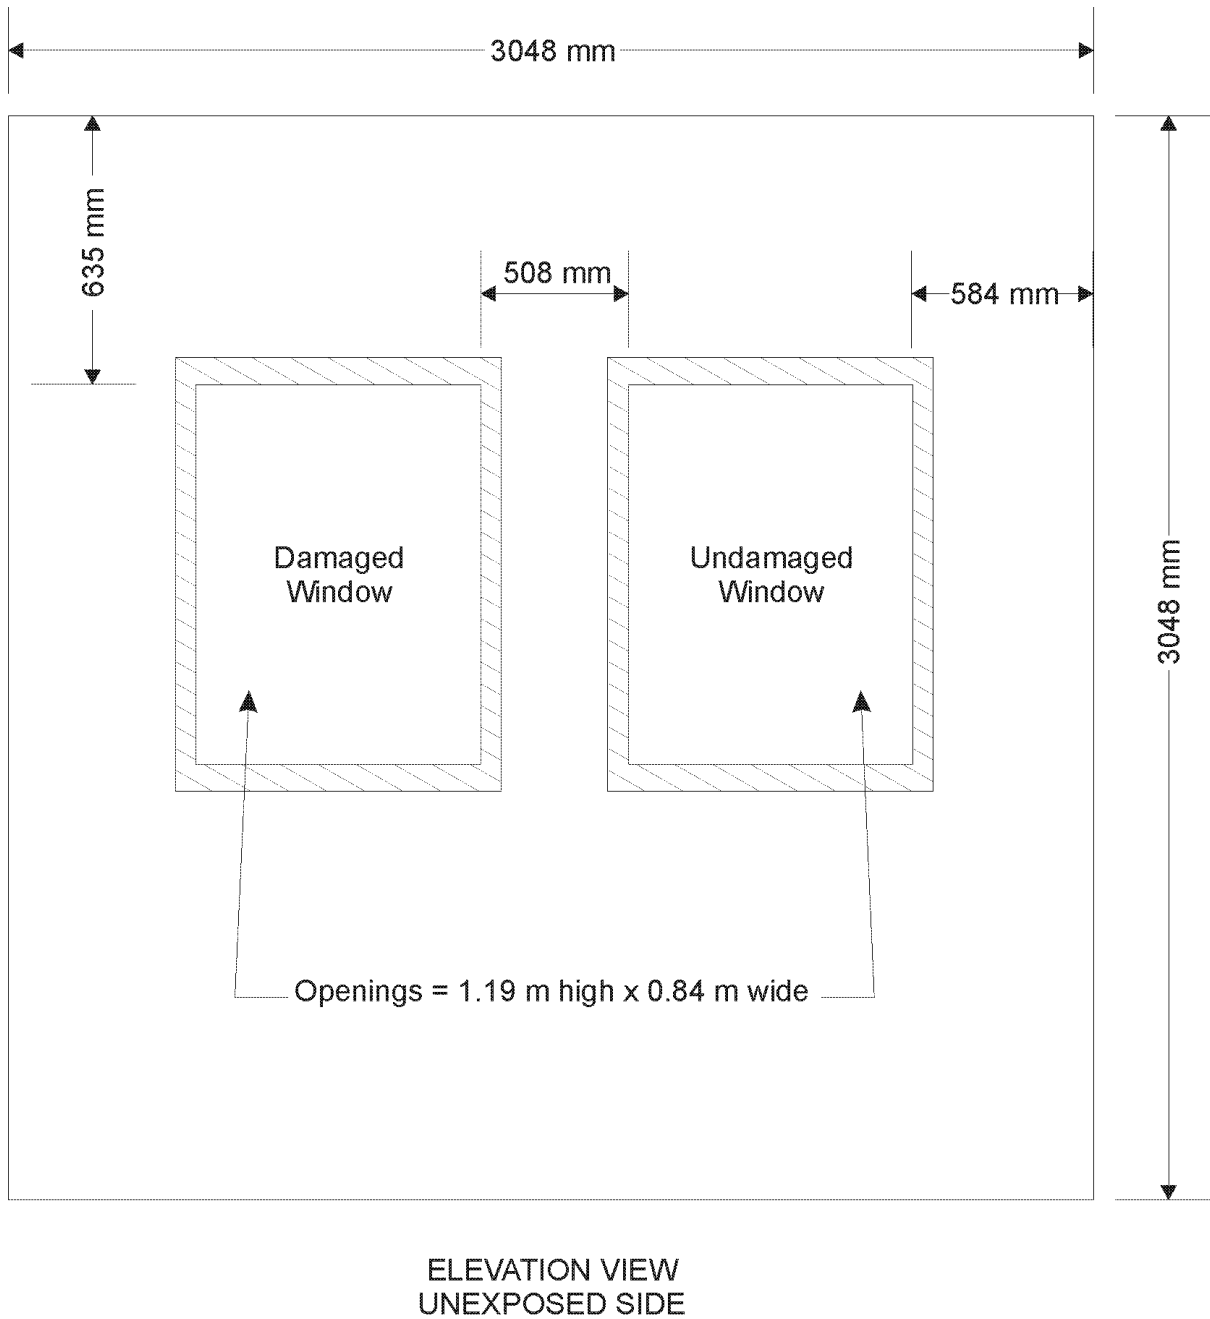
**Figure 2. Bulkhead window openings.**

Each bulkhead had two openings as shown in Figure 2. After installation of the test window assemblies into these openings, the bulkhead was insulated on the fire exposed (stiffener) side. The insulation consisted of two 25-mm (1-in) thick layers of 128-kg/m<sup>3</sup> (8-pcf) ceramic fiber insulation held in place by impaling on 102-mm (4-in) long insulation pins, spaced nominally 304 mm (12 in) on center. The insulation was secured to the pins using 30.5-mm (1.2-in) x 38.1-mm (1.5-in) square steel speed clips. All joints were offset by a minimum of 304 mm (12 in). The insulation provided an A-60 type bulkhead assembly.

The two windows were mounted to the smooth (non-stiffener) side of the bulkhead by placing a gasket between the frame and the bulkhead and bolting each window assembly to the bulkhead.

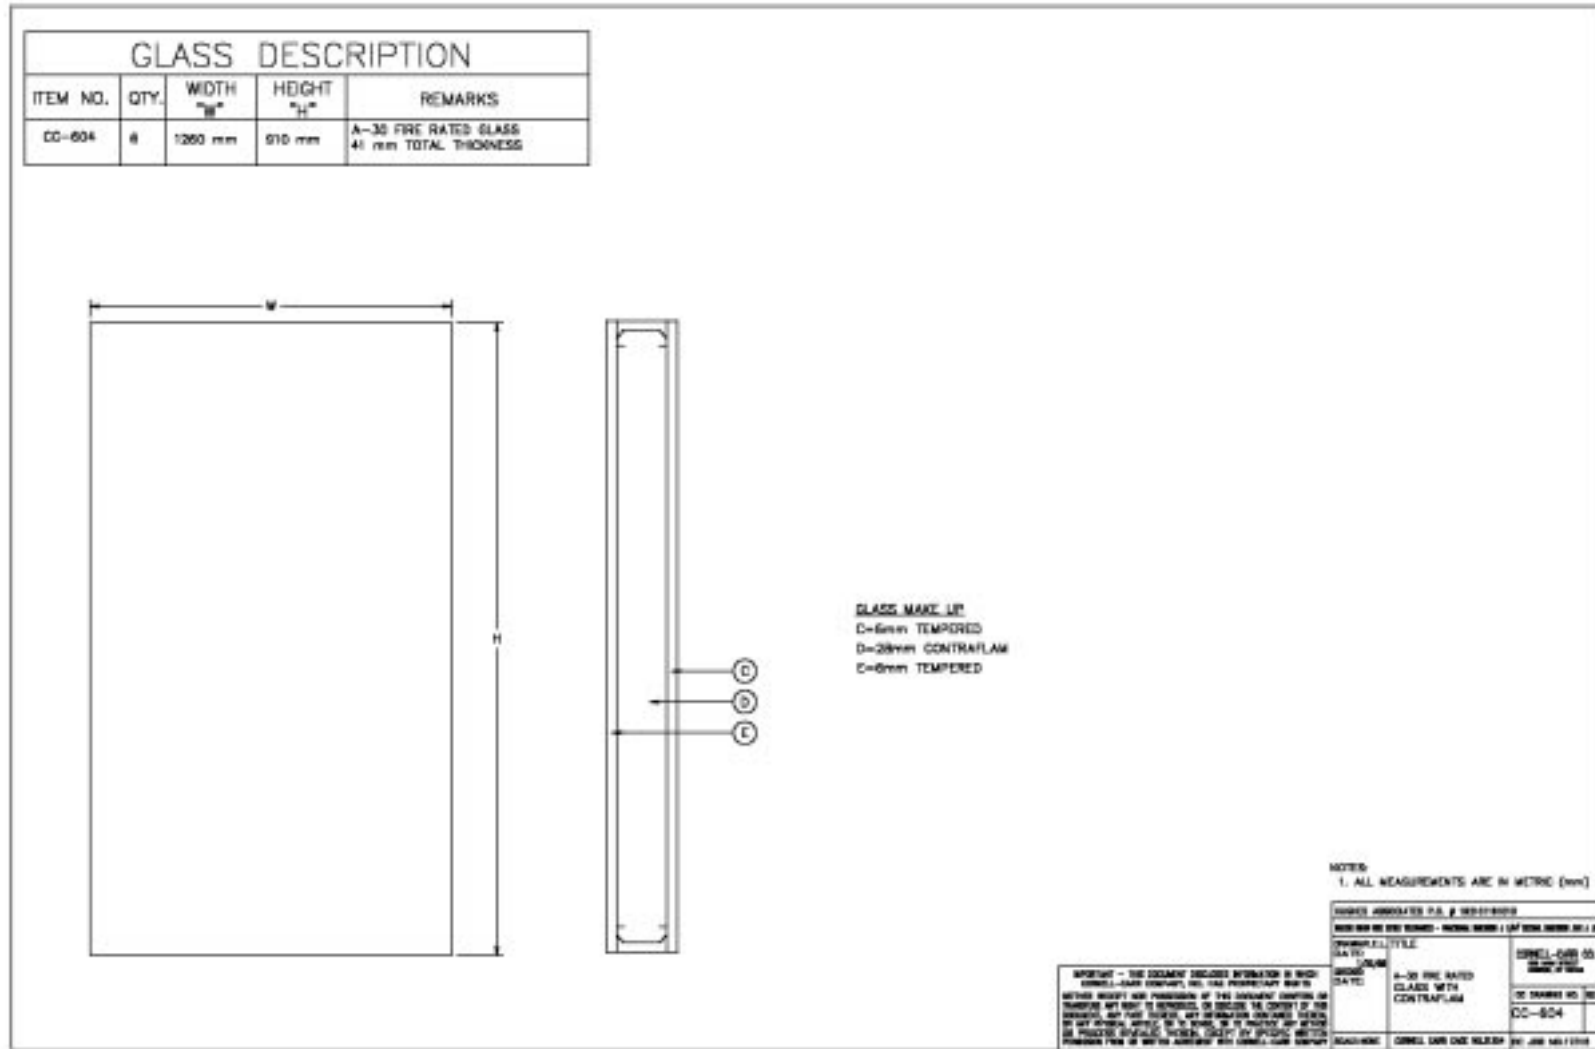
Figure 4. Drawing of the glazing reproduced with permission of Cornell-Carr Company.

Two of the window assemblies were damaged using welding slag since the failure mode under consideration in this test series involved damage of the tempered glass by welding slag. Since the postulated failure mode was that the damage to the glazing occurred during the installation of thermocouples, the unexposed side of the window assembly would be damaged. Initially, it was planned to damage the glazing on the unexposed side in one test and to damage the glazing on the exposed side in the other test. The data obtained from these two tests would assist in providing guidance for future installations.

Prior to actually damaging a window assembly, a separate piece of glazing was used for experimentation. Welding slag was produced via standard arc welding and a plasma cutter. It appeared that the arc welding would produce sufficient amounts of hot slag, which would impact the tempered glass, and due to their heat, cause pits to occur in the surface of the glass.

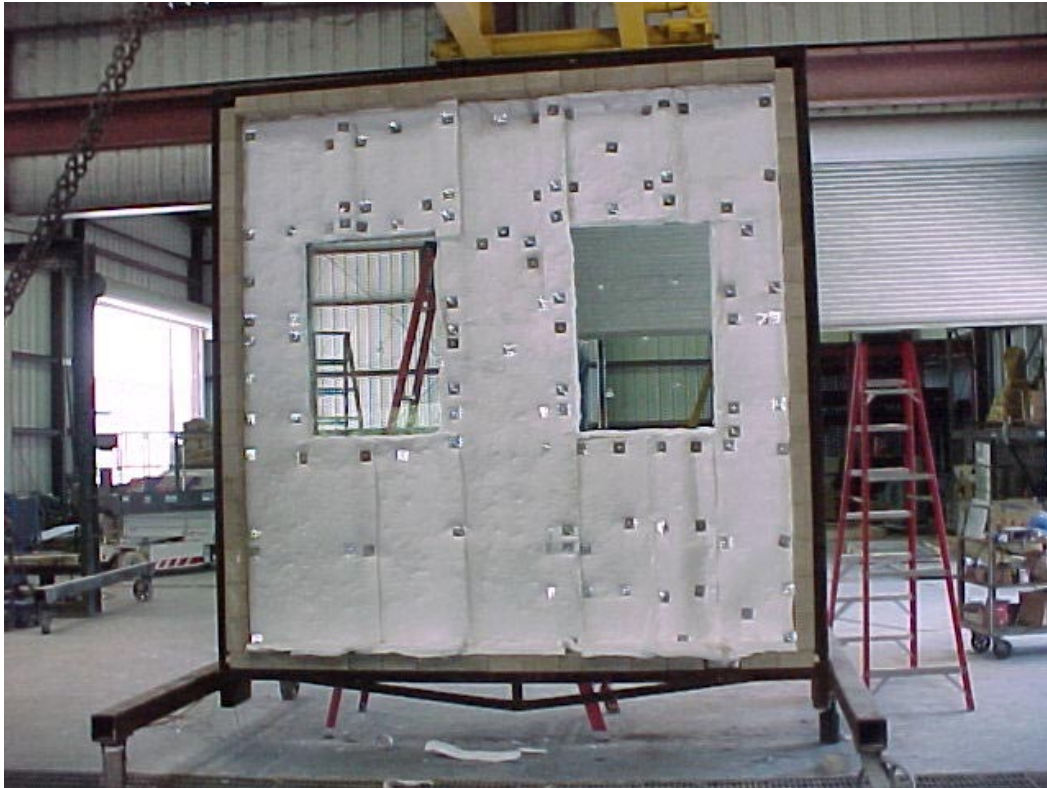
**Figure 10. Photograph of exposed face – pre-test.**

Figure 10 provides a photograph of the exposed face of the test assembly prior to test, and figure 11 provides a photograph of the test in progress. Figures 12 and 13 provide photographs of the unexposed face at 30 minutes into the test period and of the exposed face after the tests, respectively.

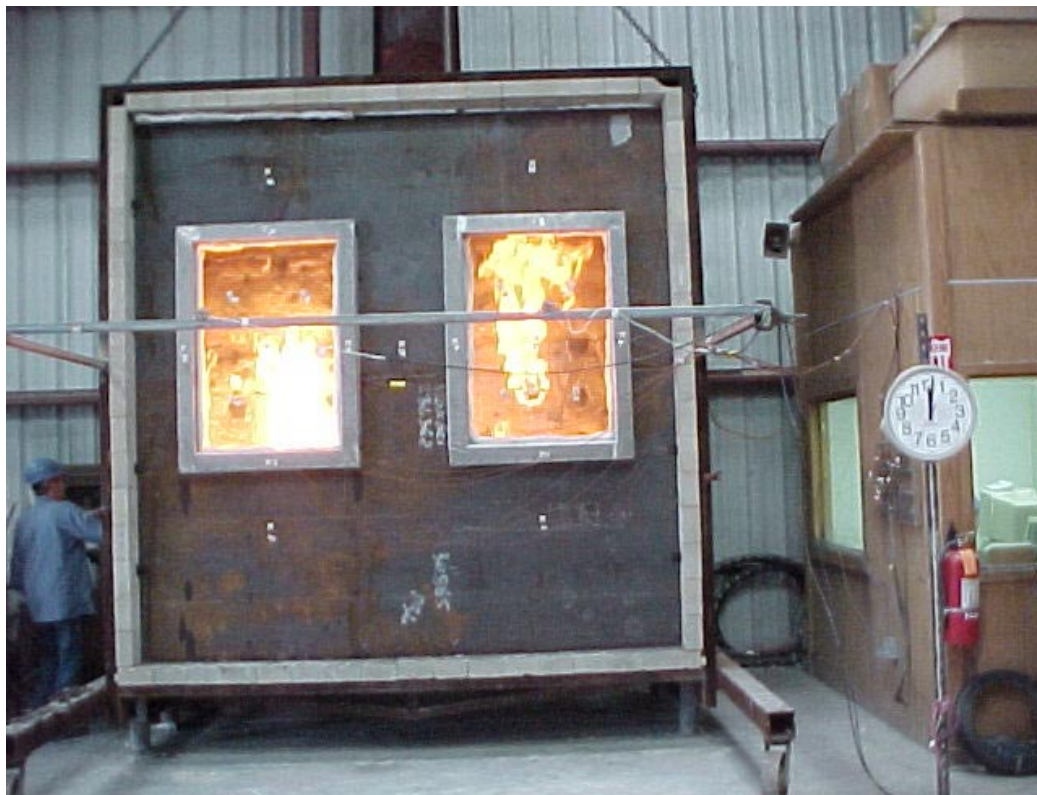
**Figure 11. Photograph of test in progress.**

<b>TIME</b> (min:sec)	<b>OBSERVATION</b>
0:00	Ignition of the furnace
2:20	Gel has separated from the glass on the exposed face of the undamaged window
2:21	Gel has separated from the glass on the exposed face of the damaged window
4:38	Inner undamaged pane of glass breaks and falls away on the damaged window
4:58	Inner pane of glass breaks and falls away on the undamaged window
~5:30	Gel on both windows has turned opaque
~16:30	Gel in both windows has turned black on exposed face
35:00	Test terminated.
